## A COMMERCIAL APPLICATION OF VIROFLOW™ TECHNOLOGY

### CASE STUDY: BLAYNEY TREATED PINE

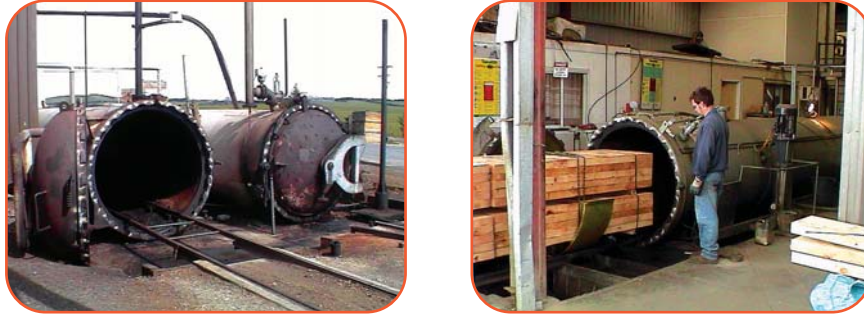
**Figure 3 – Steaming vessel (left) and timber being loaded into treatment vessel (right).**

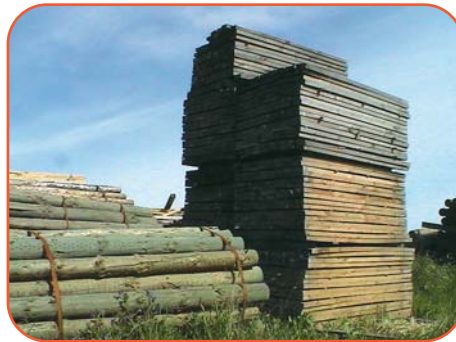
**Figure 4 – Part of the redundant treated timber storage located nearby to the leachate pond.**
