A COMMERCIAL APPLICATION OF VIROFLOW™ TECHNOLOGY

CASE STUDY: HYNE TIMBER, MARYBOROUGH, QUEENSLAND, AUSTRALIA

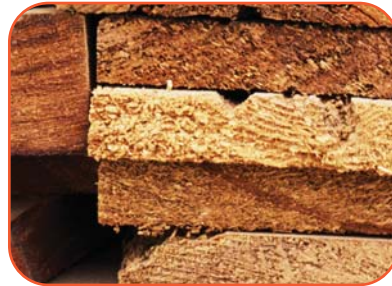
With the CCA treatment process, copper and arsenic protects timber from insect and fungal degradation. Chromium seals the copper and arsenic into the timber.

Treatment of the logs begins with a steaming process that opens the cells in the timber. Once opened, these cells stay open, allowing a more effective impregnation. The chemical treatment used is known as CCA. Copper and arsenic protect the timber from insect and fungal degradation, and chromium is used to chemically seal the copper and arsenic into the timber.

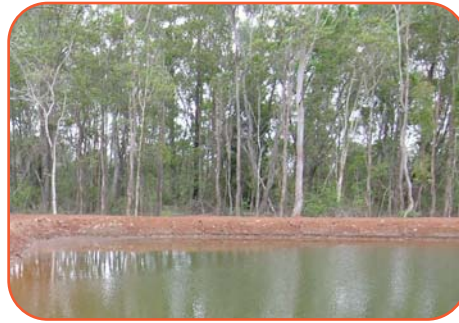
Pond #1 after ViroFlow™ Technology treatment.

Reagent A was premixed in a mixing vessel and subsequently sprayed over the surface of the ponds. The chemical effect of the lime treatment is a rise in pH.

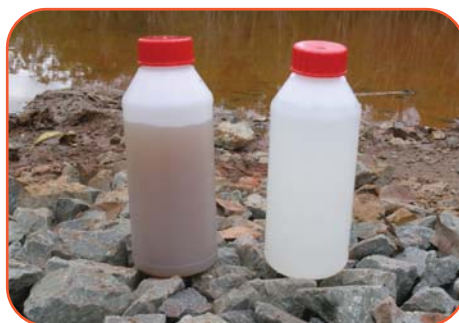
Application of ViroFlow™ Technology produced a remarkable improvement in pond water clarity. (Left:) Before treatment. (Right:) After treatment with ViroBond™ reagent.

After treatment with ViroFlow™ Technology, the CCA levels were dramatically reduced in both leachate ponds. Treatment results are summarised in Tables 1 and 2 overleaf.
