A COMMERCIAL APPLICATION OF VIROFLOW™ TECHNOLOGY

CASE STUDY: LARGE CCA TREATMENT PLANT

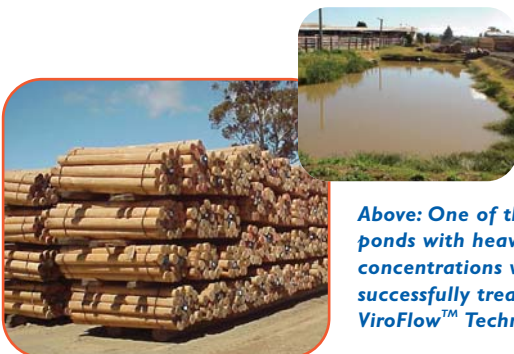
Above: One of the leachate ponds with heavy metal concentrations which were successfully treated with ViroFlow™ Technology.

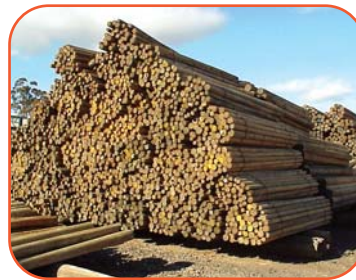
Figure 1 – Air-dried treated logs.

After treatment, the logs are stored in a holding bay, where they are air-dried. During the warmer months the minimum holding time is five days, whereas the minimum holding time in the colder months is 12 days. Water containing CCA often seeps from the logs as they are drying. The leachate is contaminated with copper, chromium and arsenic and when it rains, it is washed into collection ponds at the back of the site.

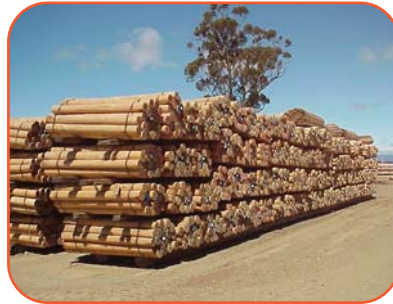
Figure 2 - The treated timber storage.

Treatment of the logs begins with a steaming process that opens the cells in the timber. Once opened, these cells stay open, allowing a more effective impregnation. The chemical treatment used is known as CCA. Copper and arsenic protect the timber from insect and fungal degradation, and chromium is used to chemically seal the copper and arsenic into the timber. The amount of CCA used at the plant is approximately 105 tonnes per year.

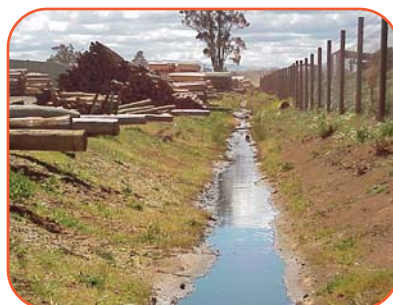
Figure 3 - The stormwater drain leading from the timber storage area to leachate pond.

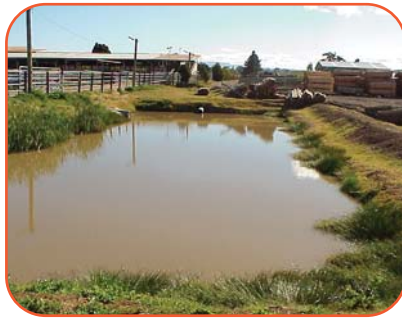
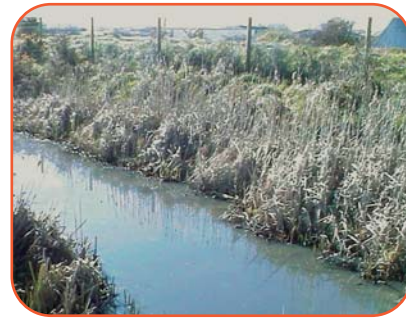
Figures 4 & 5 - Leachate ponds at the facility.

TABLE 1: LEACHATE POND NO.1 – POND CAPACITY: 300,000 L

Analyte	Before Treatment	After Treatment	Discharge Limit
pH	6.5	7.8	6.5 - 8.5
Copper (mg/L)	0.076	0.01	1.0
Chromium (mg/L)	0.096	0.015	0.5
Arsenic (mg/L)	0.091	0.029	0.05

TABLE 2: LEACHATE POND NO.2 – POND CAPACITY: 500,000 L

Analyte	Before Treatment	After Treatment	Discharge Limit
pH	6.8	7.9	6.5 - 8.5
Copper (mg/L)	0.142	0.01	1.0
Chromium (mg/L)	0.498	0.06	0.5
Arsenic (mg/L)	0.124	0.009	0.05

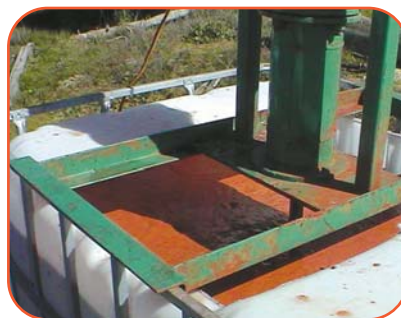
ViroBond™ Reagent Part A was premixed in a mixing vessel (see Figure 6) and subsequently sprayed over the surface of the ponds. The spent reagent was allowed to settle and form a blanket over the bottom of the ponds, where metals were permanently trapped. The pond pH was increased to 9.0 after addition of ViroBond™ Reagent Part A.

Figure 6 - Pre-mixing of ViroBond™ Reagent Part A™.

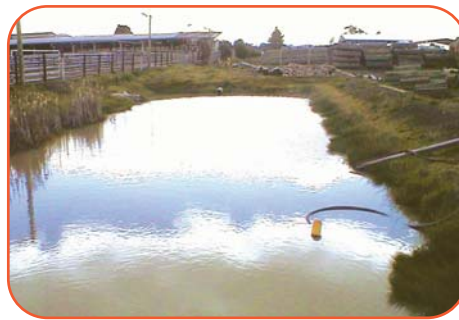
The figure below show the visual appearance of the leachate pond No. 1 post treatment. It was noticed that there was a substantial improvement in water clarity and odour.

Figure 7 – Pond No.1 after Treatment.
