AN APPLICATION OF VIROMINE™ TECHNOLOGY

CASE STUDY: MT CARRINGTON TAILINGS DAM

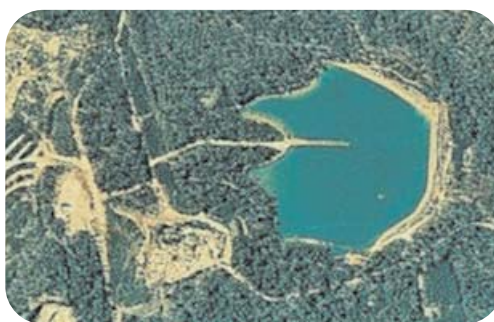
An aerial shot of the Tailings Dam.

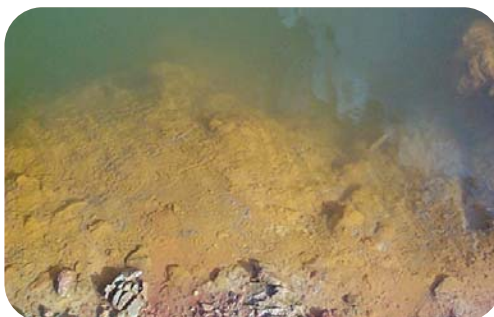
The Tailings Dam was severely contaminated and in danger of overflowing.

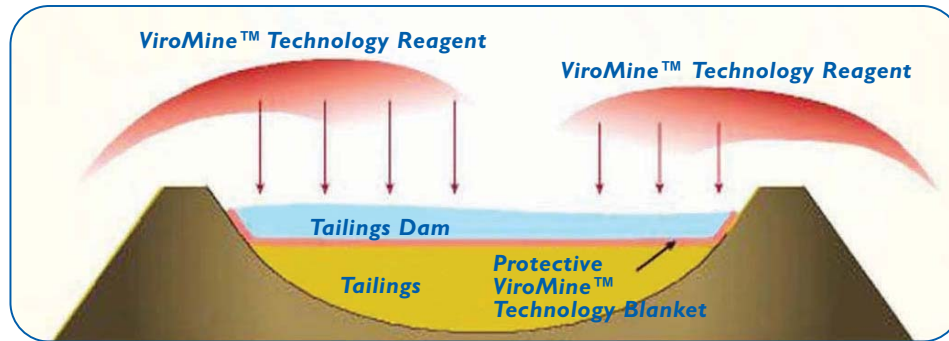
Acid B™ reagent was applied as a slurry mixture and sprayed onto the surface of the dam.

Acid B™ reagent was initially mixed into a slurry using water from the tailings dam. This slurry mixture was sprayed onto the surface of the dam. The good dispersion properties of this reagent ensured that there was an even coverage for the entire dam. The treatment produced an extremely thin and dense sediment on the floor of the dam. This sediment subsequently acted as a passive barrier for treatment of further ingress of acid mine drainage water.
