## A COMMERCIAL APPLICATION OF VIROSOIL™ TECHNOLOGY

### CASE STUDY: CLUB PELICAN GOLF, QUEENSLAND, AUSTRALIA

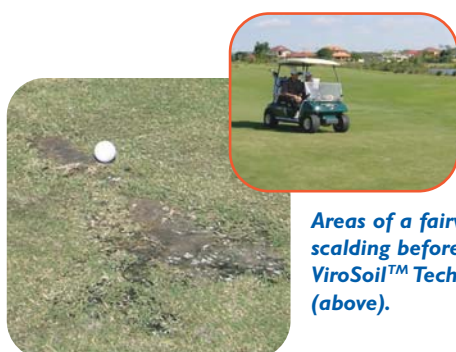
*Areas of a fairway affected by acid scalding before (left) and after ViroSoil™ Technology Treatment (above).*

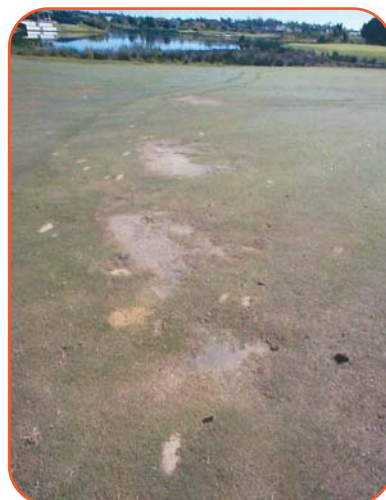
*Figure 1: ASS scalds at Club Pelican Golf.*

Conditions on the fairway at Club Pelican Golf had many of the hallmarks of a classic ASS environment. These include waterlogging, soft, fine clays, silts and estuarine sands, a grey hue to the soil, soil scalds, and yellow jarosite mottles or red iron oxide mottles can be seen in excavated soil.

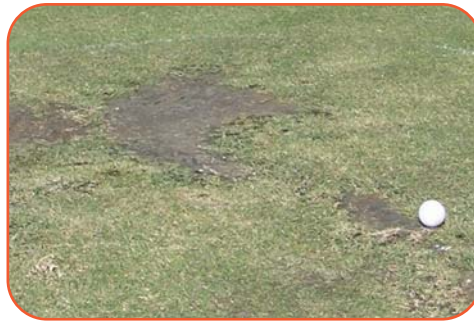
*Turf had previously been relaid several times because of acid scalds like these.*

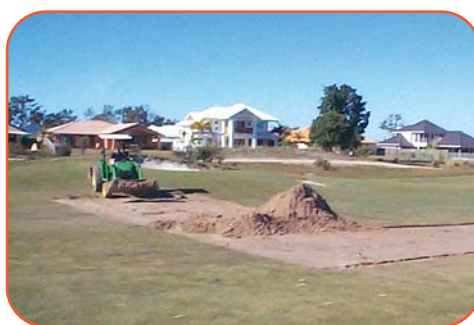
**Figure 2: Removing the turf on the affected areas.**

To rectify the problem, it was decided that the turf on the fairway would be stripped off (see Figure 2), so that Virotec's patented ViroBind™ reagent could be applied to the affected soil profile at a blending ratio to be determined by Virotec's computerised ASS treatment model, and the turf would be replaced together with some fresh top soil over the project area. The treatment areas would be monitored but largely left to weather for six to eight months and then re-sampled to assess the ASS characteristics of the soil.

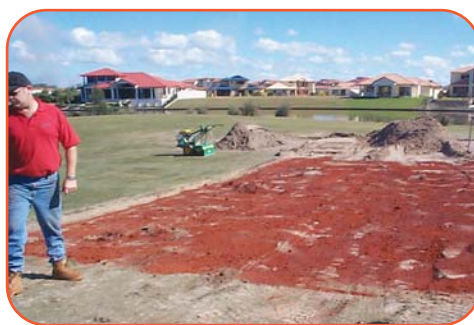
**Figure 3: Applying the ViroBind™ reagent to the treatment area.**

Three treatment areas were identified, with the first (in the foreground of Figure 3) being an area of substantial acid scalding to which the ViroBind™ reagent was applied as a layer at a depth of about 100mm and mixed lightly by rotary hoe. The second treatment area (in the back-ground of Figure 3) was a similar size area where ViroBind™ reagent was thoroughly mixed with the clay and sand components to a depth of approximately 200mm. The third treatment area (to the left in the background of Figure 3) was a control area that was simply stripped and re-turfed with no addition

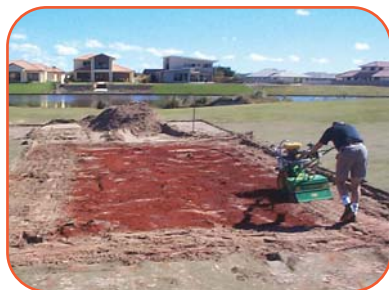
**Figure 4 (Left):** Mixing the ViroBind™ reagent into the sand and clay of the first treatment area by rotary hoe.

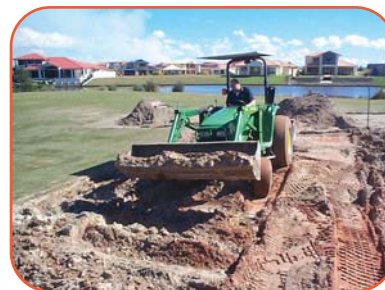
**Figure 5 (Right):** Top soil being applied prior to turf being relaid.

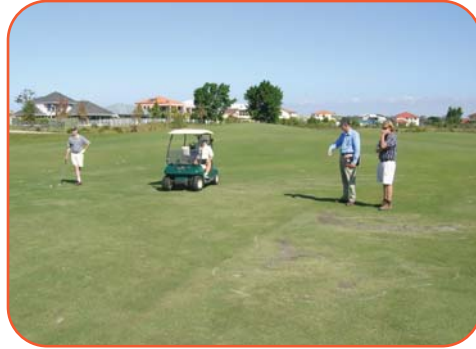
**Figure 6 (Left):** After eight months, the treated areas to the left contrast with the untreated areas with acid scalds to the right.  
**Figure 7 (Right):** In the fully mixed treatment area, the ViroBind™ reagent was evenly distributed throughout the soil profile at 200mm.

After eight months, as shown in Figure 6 (see overleaf), it was clear that the ViroBind™ reagent treatment had effectively remedied the scalds and the Riley's Super Sport Couch fairway grass had fully re-grown, with no acid scalds reappearing.

This observation was confirmed by laboratory analysis of soil samples taken after eight months, which indicated that the oxidisable S content of the soil and the total potential acidity of both the lightly mixed and fully mixed treatment areas had been significantly reduced. Acid scalding continued to occur in surrounding areas of the fairway that had not been treated (e.g. to the right of Figure 6 which can be seen overleaf).

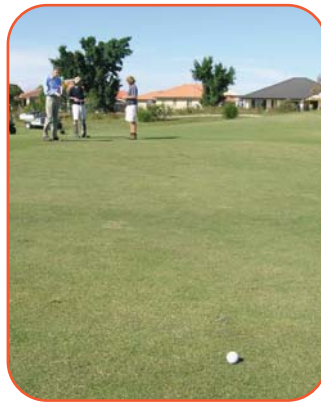
**Area treated with ViroSoil™ Technology shows no sign of scalding after 8 months.**
