A COMMERCIAL APPLICATION OF VIROFLOW™ TECHNOLOGY

CASE STUDY: PILK'S PINE, LOWANNA, NSW CCA - CONTAMINATED SOIL, LIQUID AND SLUDGE TREATMENT AND DISPOSAL

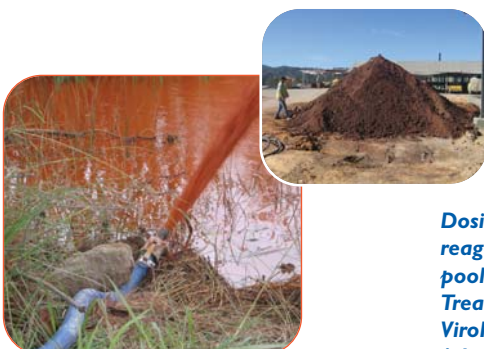
*Dosing of ViroBond™ reagent into leachate pool (left).
Treated soil after ViroFlow™ Treatment (above).*

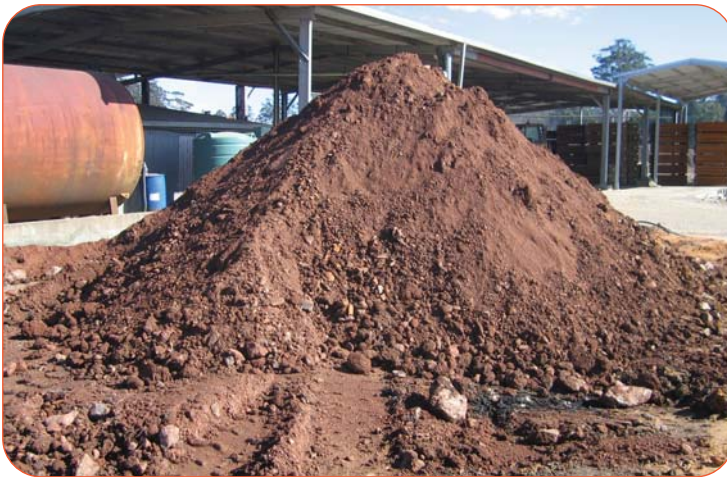
A portion of the untreated CCA solid waste prior to treatment

Virotec used ViroFlow™ Technology to treat and safely dispose of a stockpile of contaminated soil. The key objective was to immobilise the solid waste containing copper, chromium and arsenic. The process was performed in accordance with New South Wales EPA guidelines and under an authorisation granted to Virotec by Richmond Valley Council for disposal.

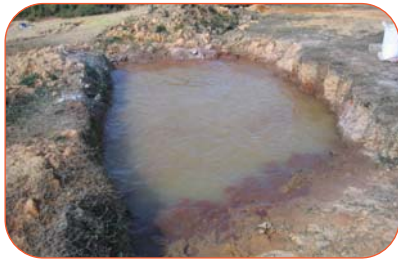
Water contained in the pit shown above was also treated using ViroFlow™ Technology

In response to a request from Pilks Pine, Virotec Global Solutions also used ViroFlow™ Technology to treat the water in a 1,000,000 L leachate pond, after adding all of the contaminated water from a nearby pit (2,000 L). The treatment was designed to immediately lower copper, chromium and arsenic (CCA) concentrations to below NSW EPA treatment targets; and to improve overall water clarity. The affected pond had CCA loads that exceeded discharge limits and there was a need to minimise environmental risk. The sludge in the bottom of the pond was also contaminated and needed to be isolated.

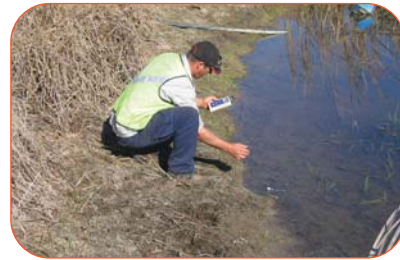
Water testing of the leachate pond prior to implementing ViroFlow™ Technology

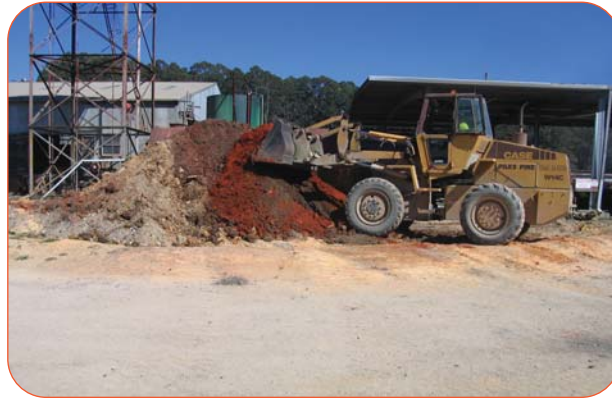
Treatment was applied using a loader

Virotec's proprietary ViroBond™ reagent is used for the treatment and immobilisation of copper, chromium and arsenic. ViroBond™ reagent was mixed with the solid waste on an impermeable clay-lined surface, using earth-moving equipment. The total volume treated was about 60 m³.

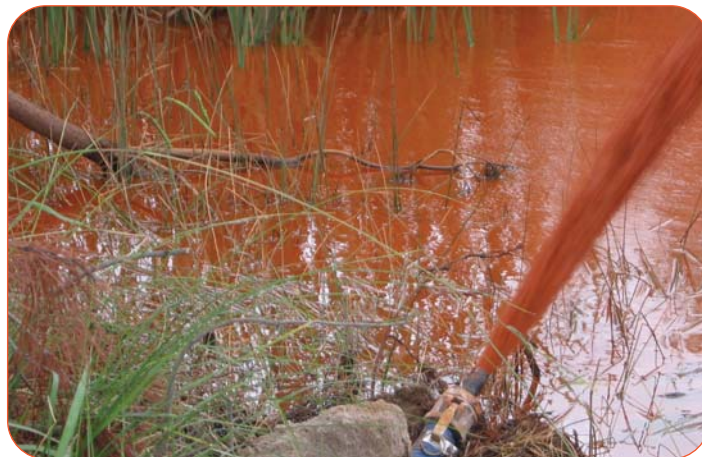
Dosing of ViroBond™ reagent into leachate pond, suspended heavy metals rapidly settle to the bottom following treatment

The ViroBond™ reagent was premixed in a mixing vessel and subsequently sprayed over the surface of the pond. The spent reagent was then allowed to settle and form a blanket over the bottom of the pond, where metals were permanently trapped.

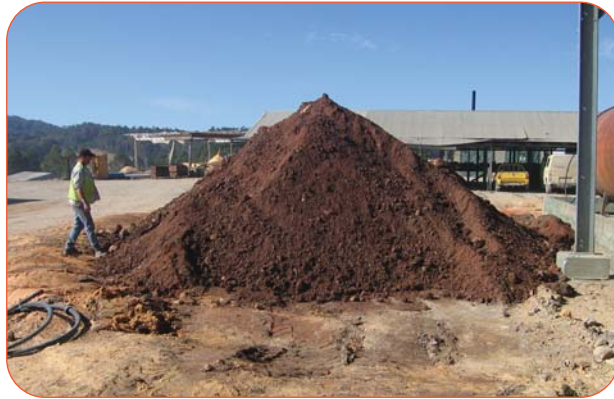
Treated CCA stockpile after ViroFlow™ Treatment

ViroFlow™ Technology successfully treated all the CCA contaminated solids to a sufficiently high standard that they met the New South Wales EPA criteria for disposal of liquid and non-liquid waste in landfill.
