A COMMERCIAL APPLICATION OF VIROSEWAGE™ TECHNOLOGY

CASE STUDY: SHANDON LAGOON, SOUTH CAROLINA, USA

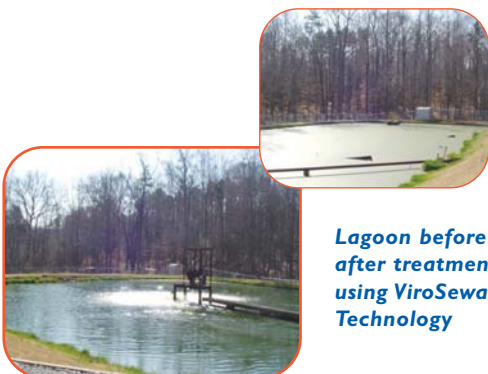
Lagoon before and after treatment using ViroSewage™ Technology

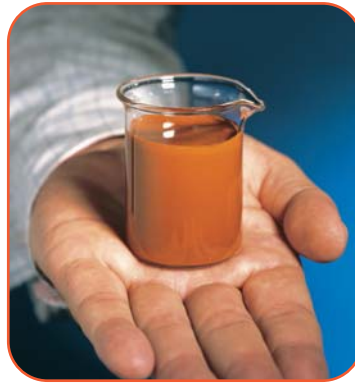
The ViroSewage™ Technology reagents were applied in slurry form to Lagoon #1. Depending on the application ViroSewage™ Technology reagents in powder or pellet form can also be used.

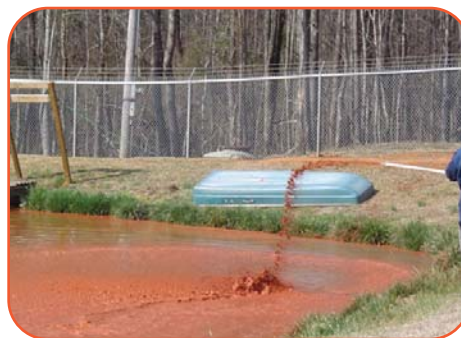
Treatment of Lagoon #1 using ViroSewage™ Technology Reagents.

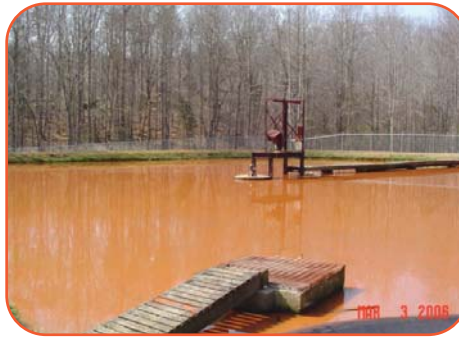
*Treatment of Lagoon #1 using ViroSewage™ Technology Reagents.
The coloured reagent settled to the bottom of a treated
water body within 48 hours.*

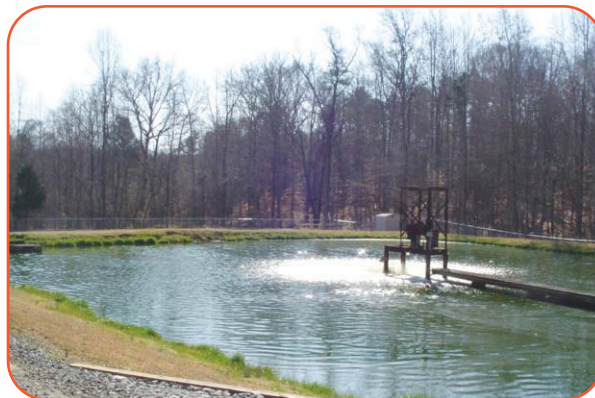
Lagoon #1 after treatment using ViroSewage™ Technology.
