## A COMMERCIAL APPLICATION OF VIROMINE™ TECHNOLOGY

### CASE STUDY: THALANGA COPPER MINES HIGHWAY REWARD MINE SITE

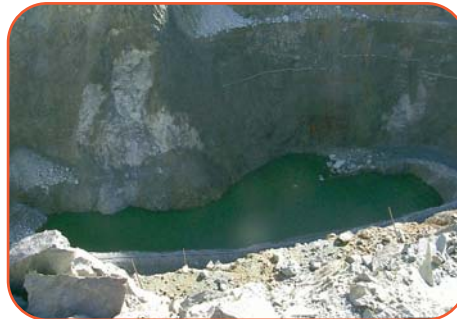
*The Highway Reward mine pit.*

At the Thalanga Copper Mine's Highway Reward mine site in central Queensland, Australia, there are several problems with acid rock drainage (ARD). During the wet season sedimentation ponds around the site are unable to cope with the large quantity of water that needs to be treated to livestock drinking water quality standards before being discharged into the local environment.

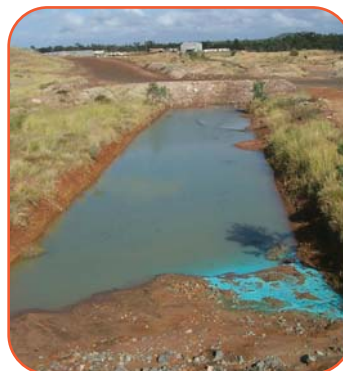
*One of the contaminated sediment ponds at Thalanga.*

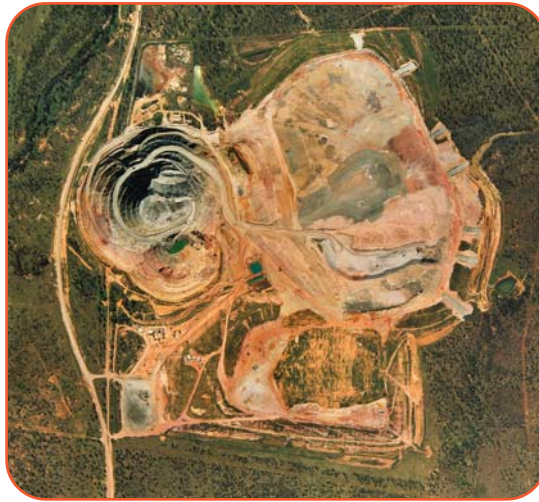
*An aerial view of the Highway Reward mine site.*

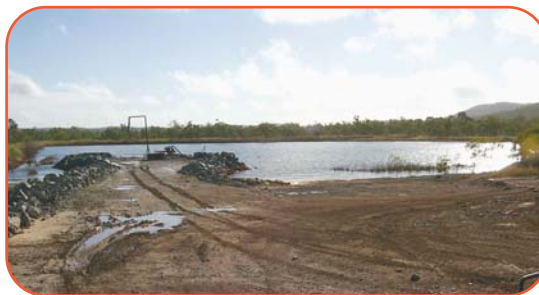
*The tailings dam at Thalanga.*

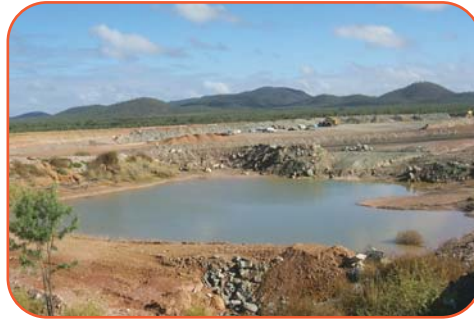
*During Australia's wet season the mine's sedimentation ponds are unable to cope with the large quantities of water generated.*

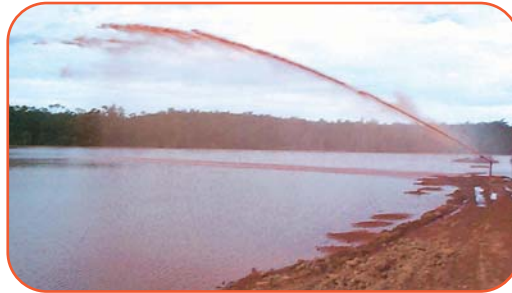
*The ViroMine™ Technology reagent was applied by a simple direct addition method as in the example shown above.*

Acid B™ reagent was prepared in a 1,000 litre mobile bulk test plant and sprayed onto the surface of the four contaminated ponds. The good dispersion properties of this reagent ensured that there was an even coverage. The treatment produced an extremely thin and dense sediment that subsequently acted as a passive barrier for treatment of further ingress of acid rock drainage water inflows.

The *in-situ* treatment method used involved no expensive capital infrastructure and a simple application procedure (see figure overleaf).
