## A COMMERCIAL APPLICATION OF VIROMINE™ TECHNOLOGY

### CASE STUDY: ROSSARDEN

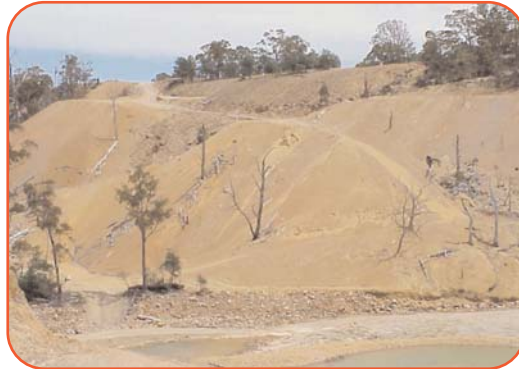
**Figure 4: A view of accumulated zinc-enriched tailings at Rossarden in 2001.**

The discharge of acidic metal-laden water from the derelict workings continue from the workings and although the impact of the acidity is localised, fish with elevated trace metal contents have been caught over a large area. Storys and Aberfoyle Creeks show severe impacts over a length of about ten kilometres.

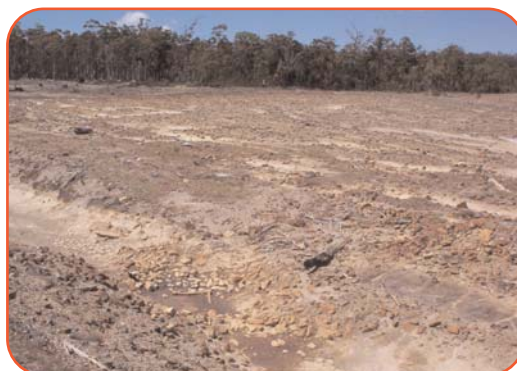
Virotec received a photograph of the site and six tailings samples from MRT to be used in a series of laboratory tests. Four of the six samples were from zinc-rich tailings (Zn-1/Zn-4) and two were from copper-rich tailings (Cu-1/Cu-2).

**Figure 5: Samples were taken from this area in the disused tailings dam.**

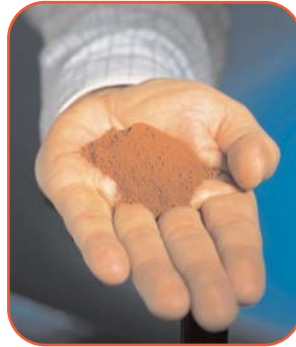
*A blend of Terra B™ reagent was used in treating the contaminated tailings.*

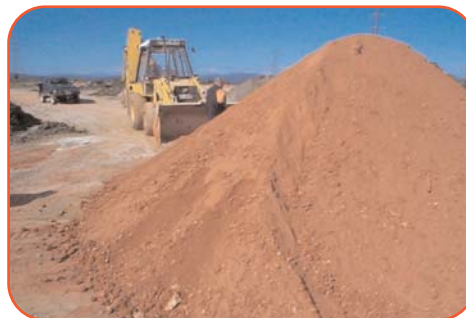
A minimum of equipment was needed to apply the treatment successfully. The Terra B™ was manufactured at a separate materials handling facility in Tasmania, where the required ingredients were assembled and mixed. Figure 6 shows the 26 tonnes of stockpiled Terra B™ at the materials handling facility prior to dispatching to Rossarden.

*Figure 6: 26 tonnes of stockpiled Terra B™ reagent at the materials handling staging area in Tasmania.*

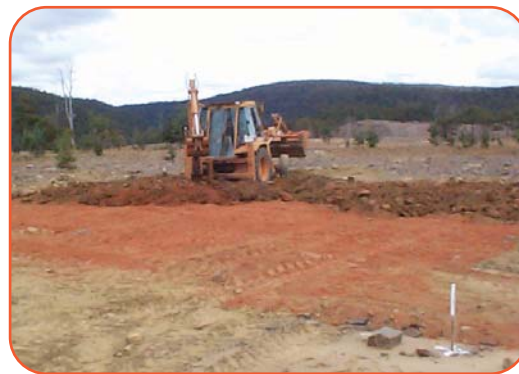
***Figure 7: Terra B™ being spread onto the zinc-enriched tailings with the backhoe.***

***Zn Tailings Area:*** Three 15m x 15m plots were marked out on the Zn tailings area. About eight tonnes of Terra B™ were applied to one plot (maximum treatment), about four tonnes were applied to another, and the third plot was left undisturbed as an untreated control. Where the Terra B™ was applied, it was first spread over the surface of the plot and then mixed in to the required depth using the backhoe.

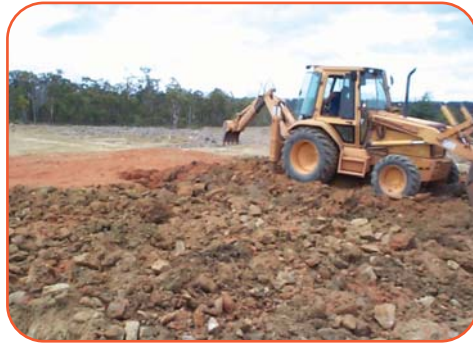
**Figure 8 (Left):** Terra B™ being mixed into the zinc-enriched tailings with the backhoe.  
**Figure 9 (Right):** The fully remediated Zn-enriched tailings plot at Rossarden prior to revegetation with poa grass seedlings.
