## A COMMERCIAL APPLICATION OF VIROFLOW™ TECHNOLOGY

# CASE STUDY: REMEDIATION OF CCA TREATMENT FACILITY, HYNE TIMBER, YANDINA, QUEENSLAND

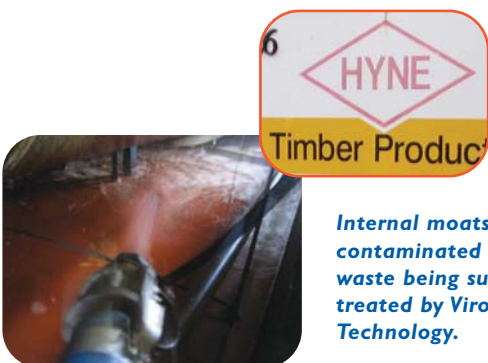
*Internal moats  
contaminated by CCA  
waste being successfully  
treated by ViroFlow™  
Technology.*

Virotec's solution involved adopting ViroFlow™ Technology using proprietary ViroBond™ reagent to effectively and permanently remove the metals from the solution and to bind them in a non-toxic layer on the bottom of the moats. The ViroFlow™ Technology treatment is a custom designed multi-stage treatment applied in three integrated stages, using the mobile ViroFlow™ Technology mixing and dosing plant to apply the ViroBond™ reagent evenly around the moats.

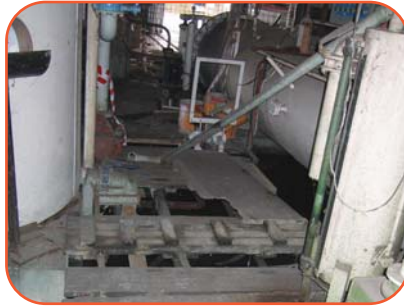
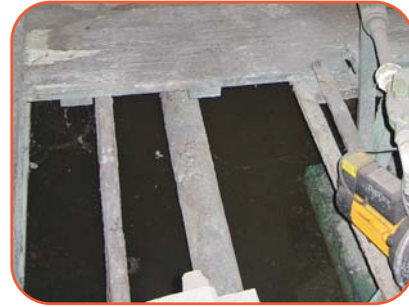
*Exposed internal moats contaminated by CCA where ViroFlow™ Technology treatment was applied. Rain seeping into the moats had elevated water levels close to their capacity, exacerbating the problem.*

However, as a result of rain seeping into the moats from outside the building, water levels in the moats began to climb towards their capacity at a rate that required a solution. The water was clearly contaminated and was unsuitable for release into the environment. Prescribed water quality standards imposed by Maroochy Shire Council were to be met before the water could be released.

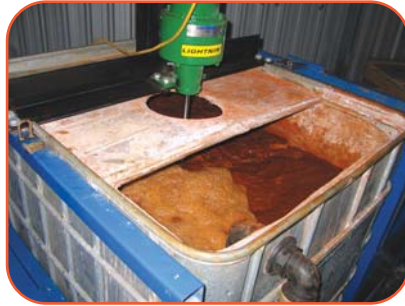
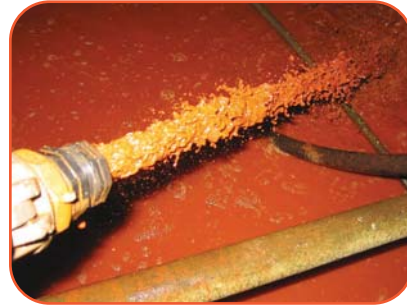
*Virotec's mobile ViroFlow™ Technology Mixing and Dosing Plant being used to treat the moats.*

ViroFlow™ Technology incorporates the use of ViroBond™ reagent, a patented environmentally safe reagent that can be added directly to the moat, leachate pond or contaminated water body or used as the active ingredient in flow-through treatment systems. When mixed with contaminated soil, or water, ViroBond™ reagent will immobilise CCA permanently to allow safe disposal and the discharge of treated water.

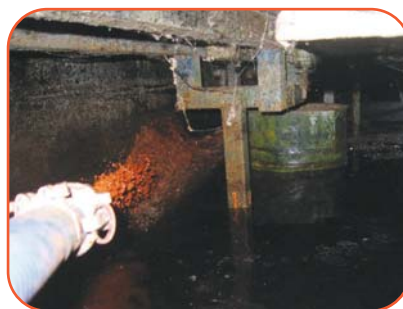
*ViroBond™ reagent being applied to another of the internal moats.*

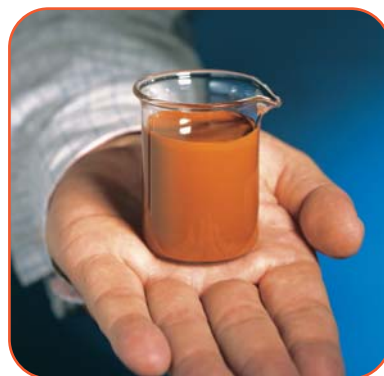
*ViroBond™ reagent immobilises heavy metals into an insoluble, non-hazardous sediment.*

ViroBond™ reagent works by forming strong chemical bonds with the copper, chromium and arsenate ions in the moat, leachate pond, or water body. ViroBond™ reagent effectively immobilises the metal into an insoluble, non-reactive sediment.

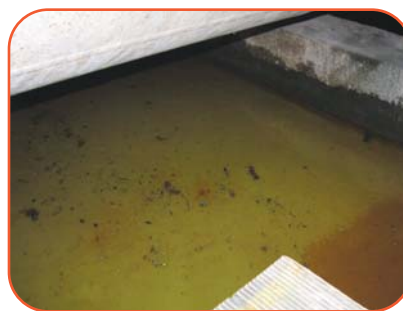
The figure below shows the clarity of the treated solution in one moat, with a layer of non-toxic sediment remaining on the bottom.

**Suspended ViroBond™ reagent particles that bound the heavy metals have settled to the bottom following treatment.**

Following treatment, the CCA concentrations were dramatically reduced in the moats. Treatment results are summarised in Tables 1 and 2 below.
