A COMMERCIAL APPLICATION OF
VIROSEWAGE™ TECHNOLOGY

CASE STUDY:
KILCOY SEWAGE TREATMENT PLANT

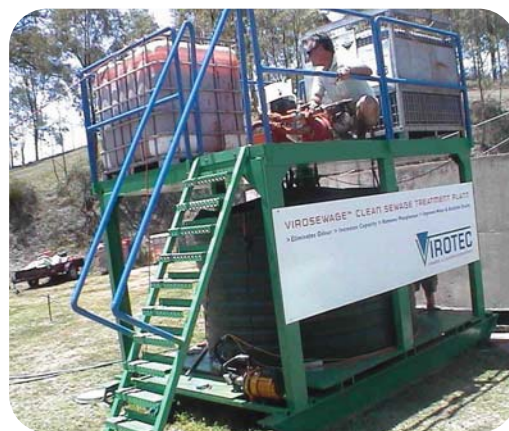
The ViroSewage™ Technology dosing plant at Kilcoy sewage treatment works.

The ViroSewage™ Technology treatment method is a fairly simple add-on to the existing treatment plant and does not require significant capital investment. The ViroSewage™ Technology dosing plant is linked to the sewage treatment plant's flow meter to ensure correct dosing of ViroSewage™ Technology reagents during the variable input flows.
