A COMMERCIAL APPLICATION OF VIROFLOW™ TECHNOLOGY

CASE STUDY: PORTLAND PINE PRODUCTS CCA - CONTAMINATED SOLIDS TREATMENT

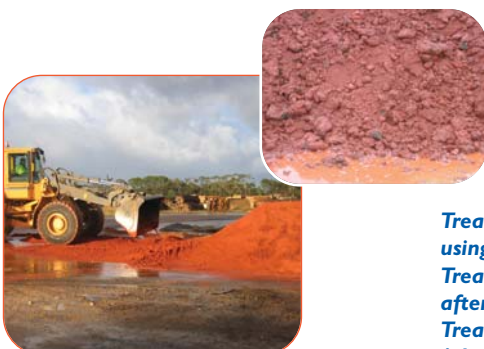
*Treatment being applied using excavator (left).
Treated CCA stockpile after ViroFlow™ Technology Treatment application (above).*

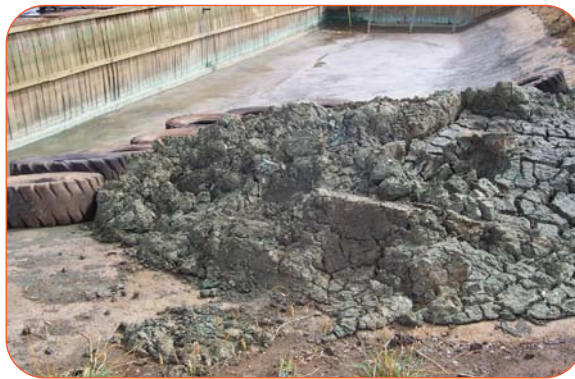
Figure 1 - Untreated CCA solid waste prior to treatment

Portland Pine Products, Victoria, embarked on a project to remove sludge from a CCA sedimentation dam and sought an economical technology to treat the CCA contaminated solids prior to disposal.

Virotec was contracted by Portland Pine Products to implement ViroFlow™ Technology to treat and safely dispose of a stockpile of CCA contaminated dam sludge. The key objective was to immobilise copper, chromium and arsenic in the excavated sludge such that the treated material would meet landfill disposal standards.

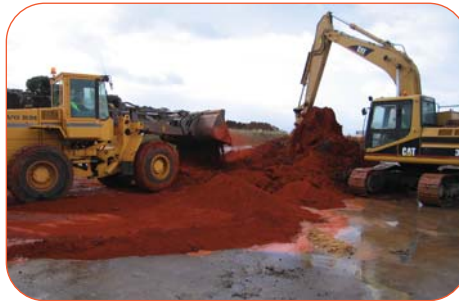
Figure 2 - Treatment was applied using an excavator and loader

ViroBond™ Reagent is Virotec's proprietary reagent for the treatment and immobilisation of copper, chromium and arsenic wastes. ViroBond™ reagent was mixed with the semi-solid waste on an impermeable concrete surface, using earth-moving equipment. Table I outlines the treatment specifications.

Total Mass of Waste Treated	Method of Mixing	Period of Mixing
<i>60 Tonne</i>	<i>Excavator and Loader</i>	<i>4 hours</i>

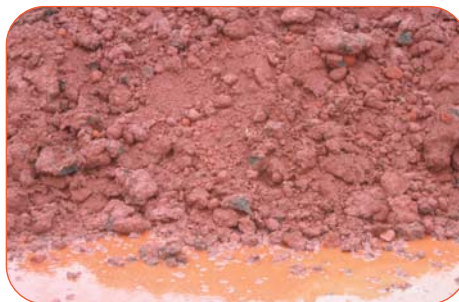
Figure 3 - Treated CCA stockpile after ViroFlow™ Technology Treatment application (wet weather during treatment produced some pooling)

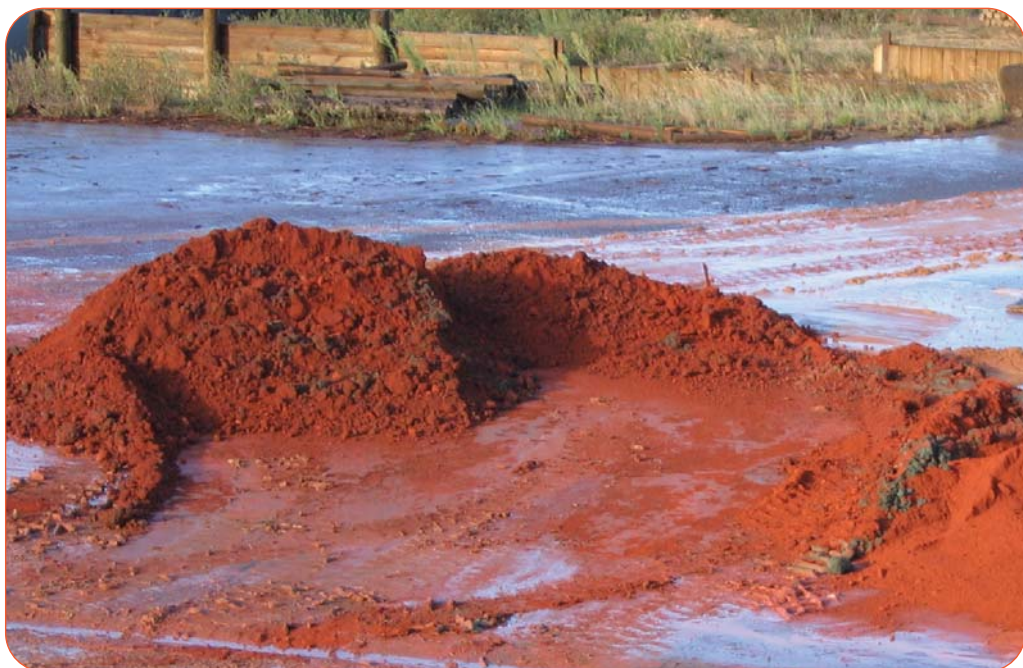
*Figure 4 - Treated CCA stockpile after ViroFlow™ Technology
Treatment waiting to be disposed of to landfill*

The contaminants held in the waste are within Victorian EPA regulatory limits for low level contaminated soil, and therefore the treated sludge could be safely disposed of to landfill.
