A COMMERCIAL APPLICATION
OF VIROMINE™ TECHNOLOGY

CASE STUDY: THALANGA COPPER MINES
HIGHWAY REWARD MINE SITE

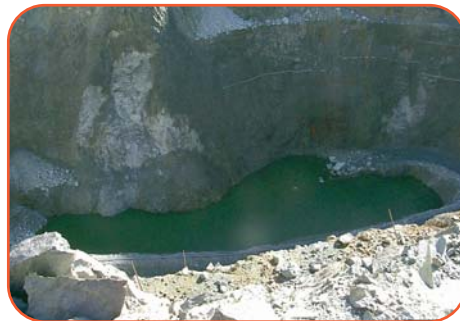
The Highway Reward mine pit.

At the Thalanga Copper Mine's Highway Reward mine site in central Queensland, Australia, there are several problems with acid rock drainage (ARD). During the wet season sedimentation ponds around the site are unable to cope with the large quantity of water that needs to be treated to livestock drinking water quality standards before being discharged into the local environment.

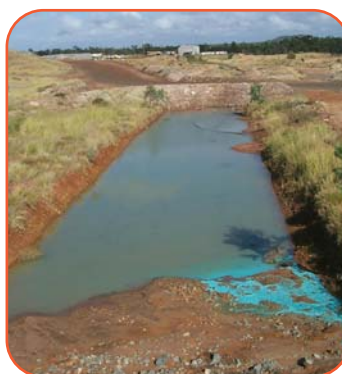
One of the contaminated sediment ponds at Thalanga.

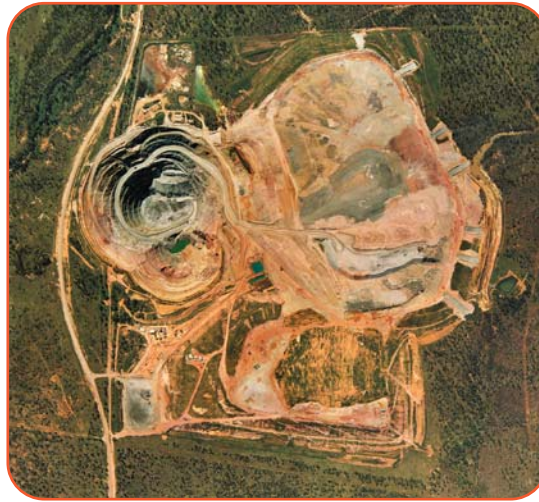
An aerial view of the Highway Reward mine site.

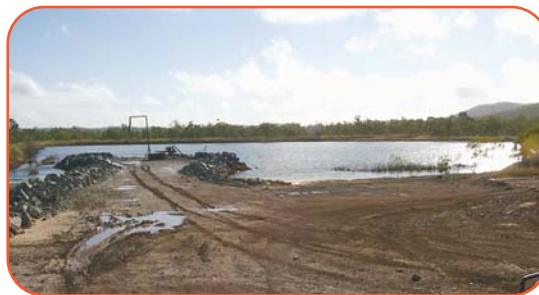
The tailings dam at Thalanga.

When underground mining commenced, large quantities of mine water needed to be pumped to the surface; this water was collected in an old tailings dam. In the view of onsite personnel, the volume of water being pumped from underground would have soon exceeded the capacity of the tailings dam and they anticipated the need to release water all year round. During the dry season Thalanga Copper Mines did not have the benefit of being able to dilute the water before release and therefore another method for treatment was required. As an interim step, the mine was also considering raising the dam wall to provide a greater holding capacity.

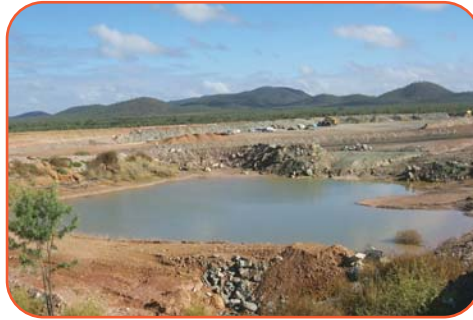
During Australia's wet season the mine's sedimentation ponds are unable to cope with the large quantities of water generated.

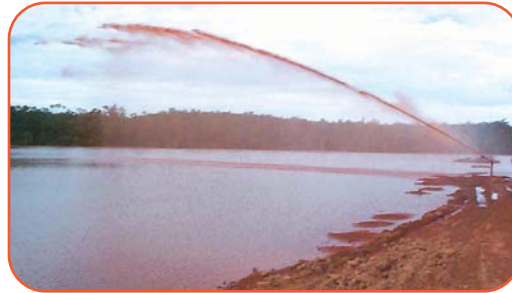
The ViroMine™ reagent was applied by a simple direct addition method as in the example shown above.

Acid B™ was prepared in a 1,000 litre mobile bulk test plant and sprayed onto the surface of the four contaminated ponds. The good dispersion properties of this reagent ensured that there was an even coverage. The treatment produced an extremely thin and dense sediment that subsequently acted as a passive barrier for treatment of further ingress of acid rock drainage water inflows.

The *in-situ* treatment method used involved no expensive capital infrastructure and a simple application procedure (see figure overleaf).
