## A COMMERCIAL APPLICATION OF VIROSOIL™ TECHNOLOGY

### CASE STUDY: MAJOR AUSTRALASIAN CIVIL CONTRACTING COMPANY, HYDROCARBON TREATMENT

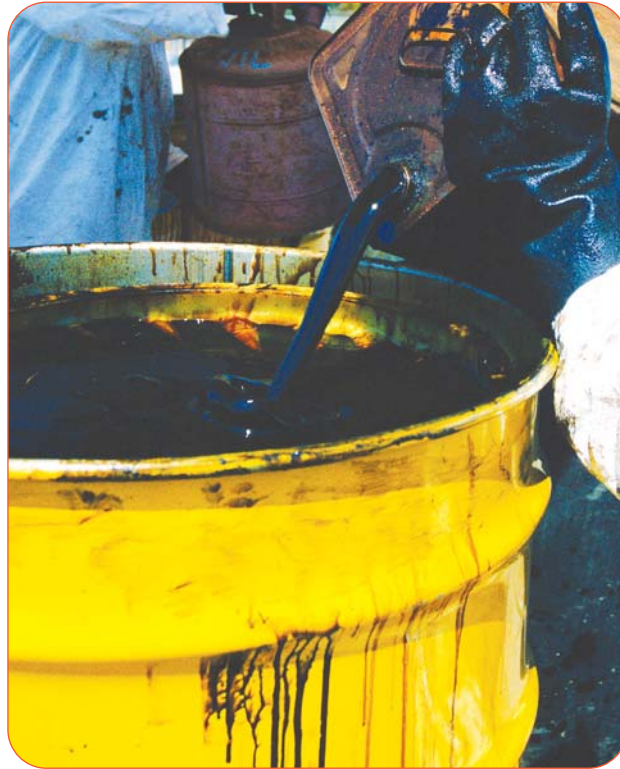
*Figure 1 - Soil contaminated by hydrocarbons such as oils is just one of the many serious waste streams identified worldwide.*

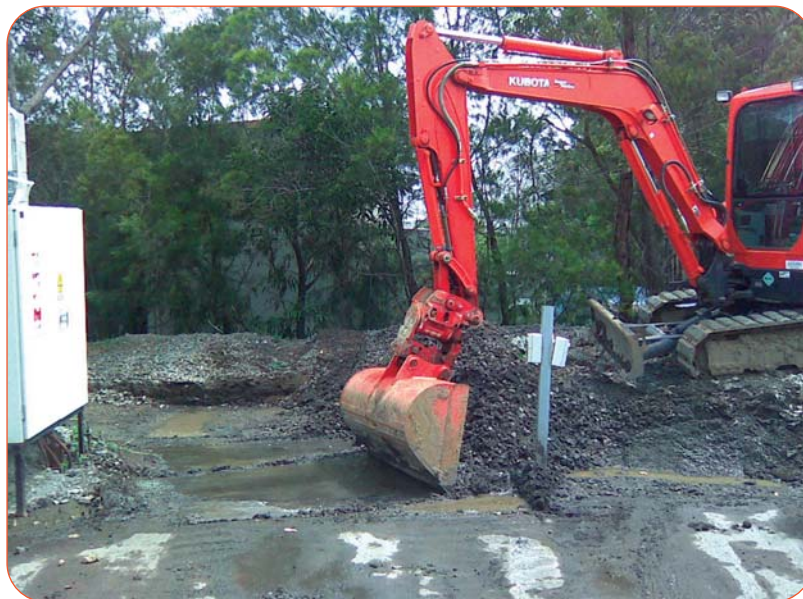
*Figure 2 - Contaminated area at the Yatala site*

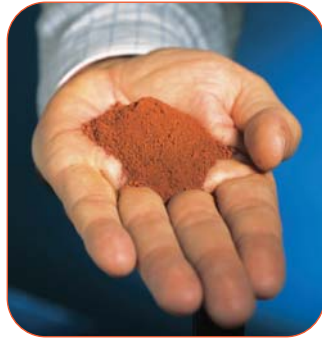
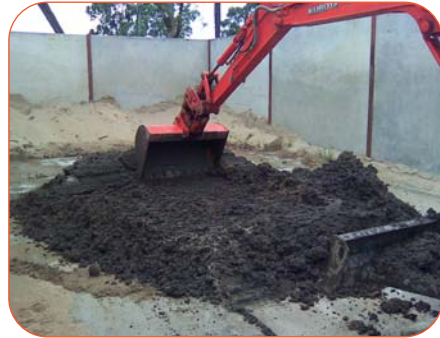
**Figure 3 - ViroBind™ reagent (left) being added to the contaminated site prior to mixing (right).**

The Yatala site was treated using ViroSoil™ Technology. The RSD method employed involves adding a patented mixture of bacteria, enzymes, nutrients and surfactants to condition the soil prior to mixing.

The contaminated soil was excavated from the contaminated source, scraped and piled using a bobcat loader into large piles in designated treatment areas and irrigated on a regular basis to optimize the dispersion and aeration of enzymes and to provide both the indigenous and introduced microbes with optimal growth and performance conditions
